# Vehicle Inspection Report

## BMW X5 xDrive40i

2019 · GCC specs · 78,450 km · Mineral White

REPORT NO.  
PPI-2026-0000

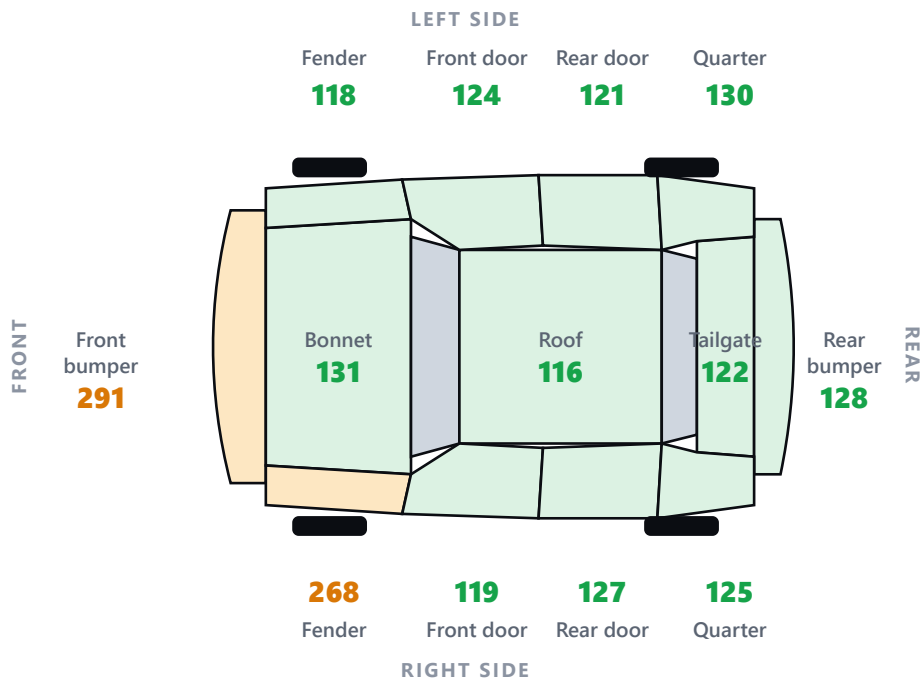
Paint thickness in microns (µm), measured on every panel with a digital gauge.

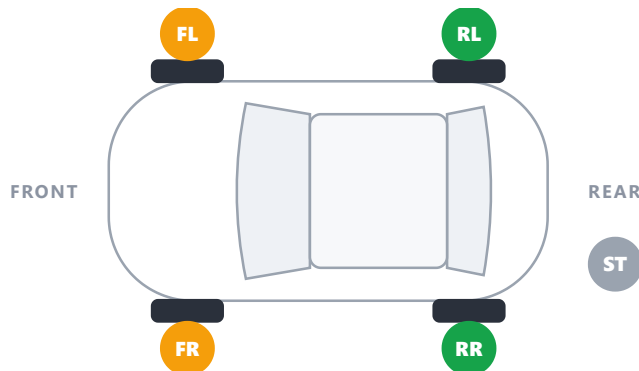
Spare tyre (ST)  
None. Run-flat tyres fitted
